ERDC/EL SR-01-2

**Biological Assessment of Streams  
Associated with the Northern Training  
Complex at Fort Knox, Kentucky,  
August 2000**

Final report

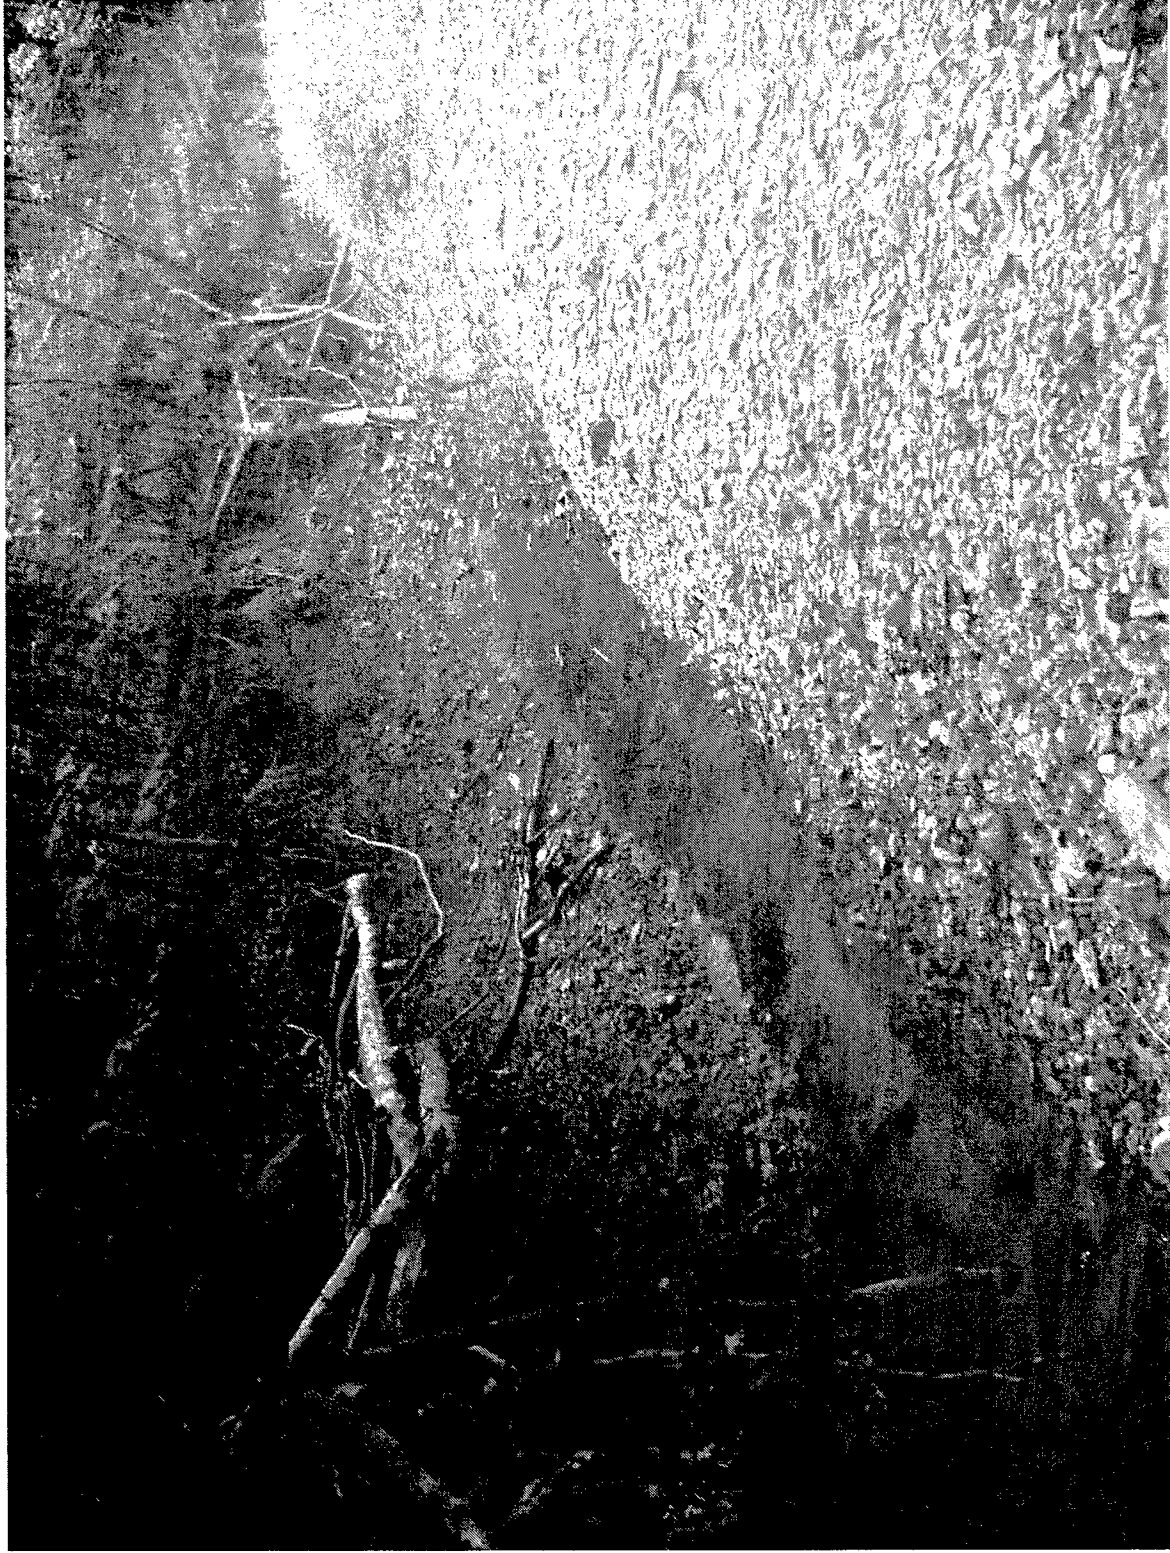
The upstream site (Site 1) in this creek was a narrow, linear pool along the right descending bank (Photograph 2). This pool along the cut bank was the deepest part of the streambed. The pool was approximately 150 feet long, averaged 2 to 4 feet wide, and water depth averaged 0.5 ft. Maximum depth was approximately 1.5 feet at the downstream end of the pool in a scour hole formed below a large tree. Substrate was mostly cobble with a substantial amount of gravel and sand with some organic debris (Table 2). Coarse particulate organic matter (CPOM, coarse particulate matter comprised of tree leaves, wood, and twigs) and organic muck (FPOM, fine particulate organic matter resulting from degradation of CPOM) were present in small quantity along the bottom of the pool. The remaining (dry) streambed at this site was a flat cobble riffle that extended from the pool to the left descending bank (Photograph 2).

Photograph 2. Upstream view of Site 1 in Cedar Point Branch showing pooled water along cut bank and cobble of dry streambed.

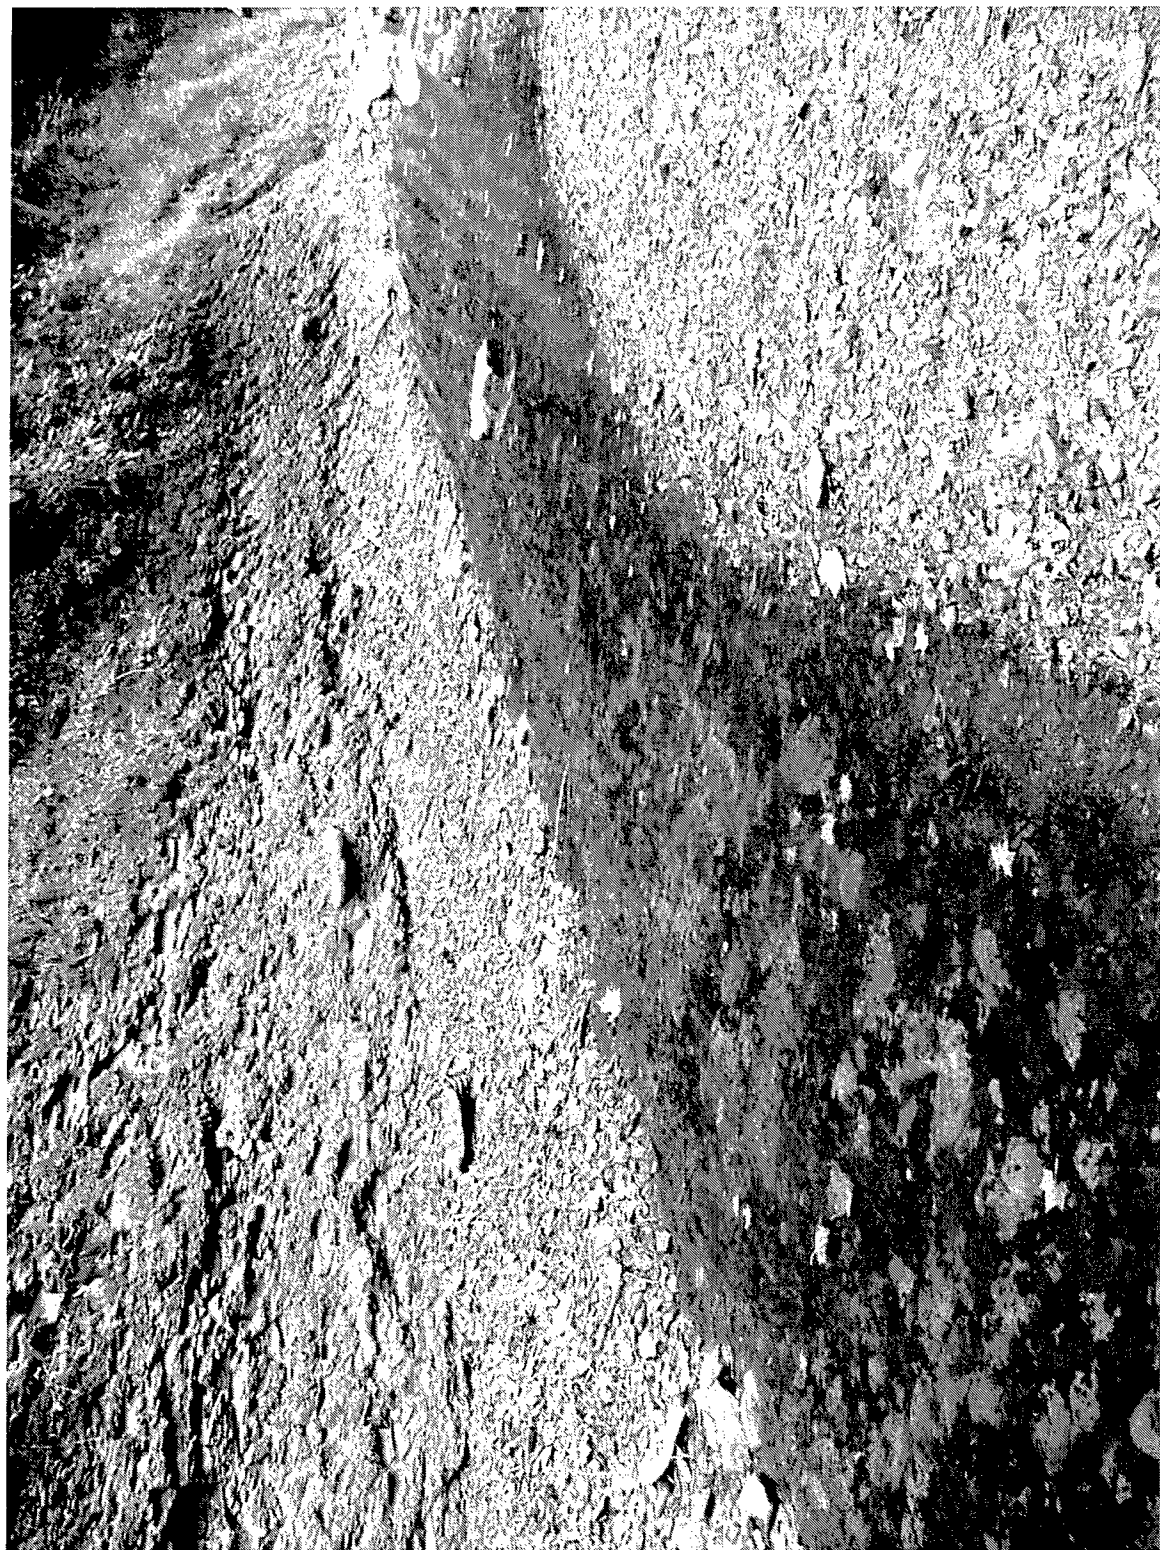
Site 2 was approximately 300 feet downstream of Site 1 and was a long (150 ft), shallow (0.5 ft), wide (10 ft) pool along the left descending bank (Photograph 3). The left bank was a vertical cliff of clay and substratum was "bedrock" of scoured, hard clay. Sand, gravel, and cobble were present along the right margin and both ends of this pool. Extensive FPOM littered the hard clay (Photograph 4). CPOM was abundant in a relatively deep pool (2.5 ft) at the upstream end of the entire pool. Water velocity was 0 ft/sec.

Photograph 3. Downstream view of Site 2 in Cedar Point Branch, a wide and shallow pool along the base of the vertical cliff that forms the left descending bank.

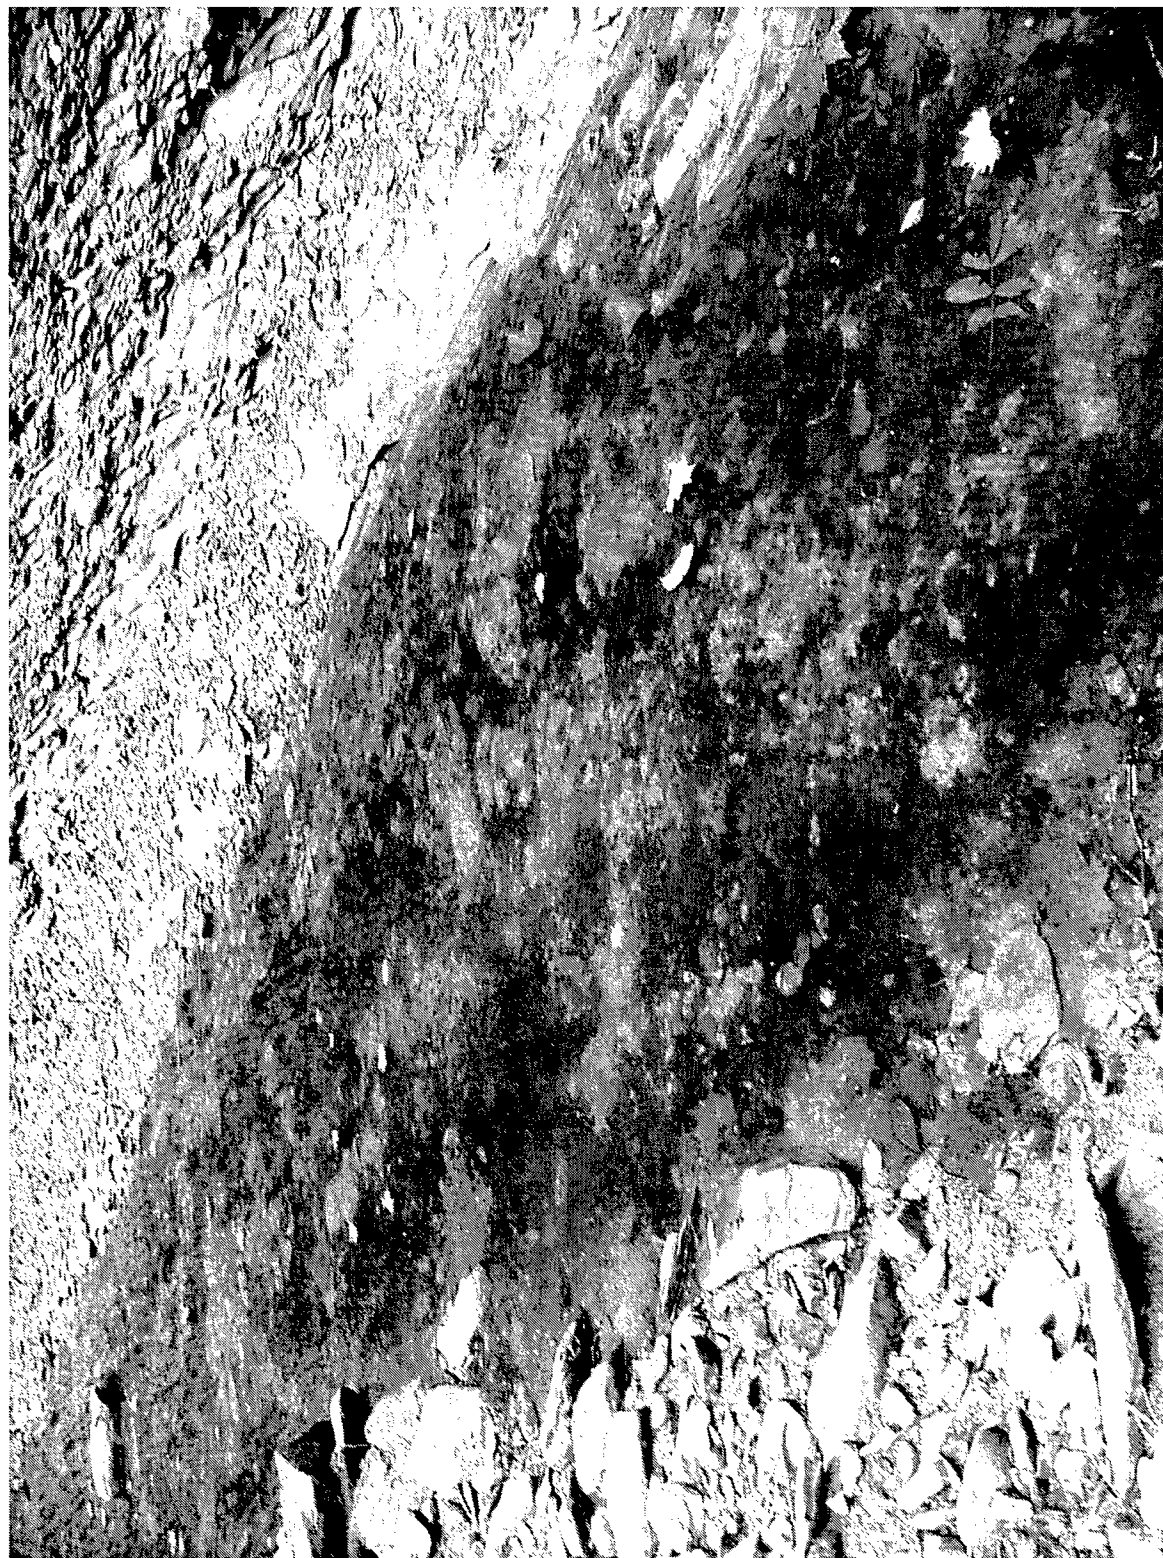
Photograph 4. Fine Particulate organic matter (FPOM) accumulated in Site 2 in Cedar Point Branch.

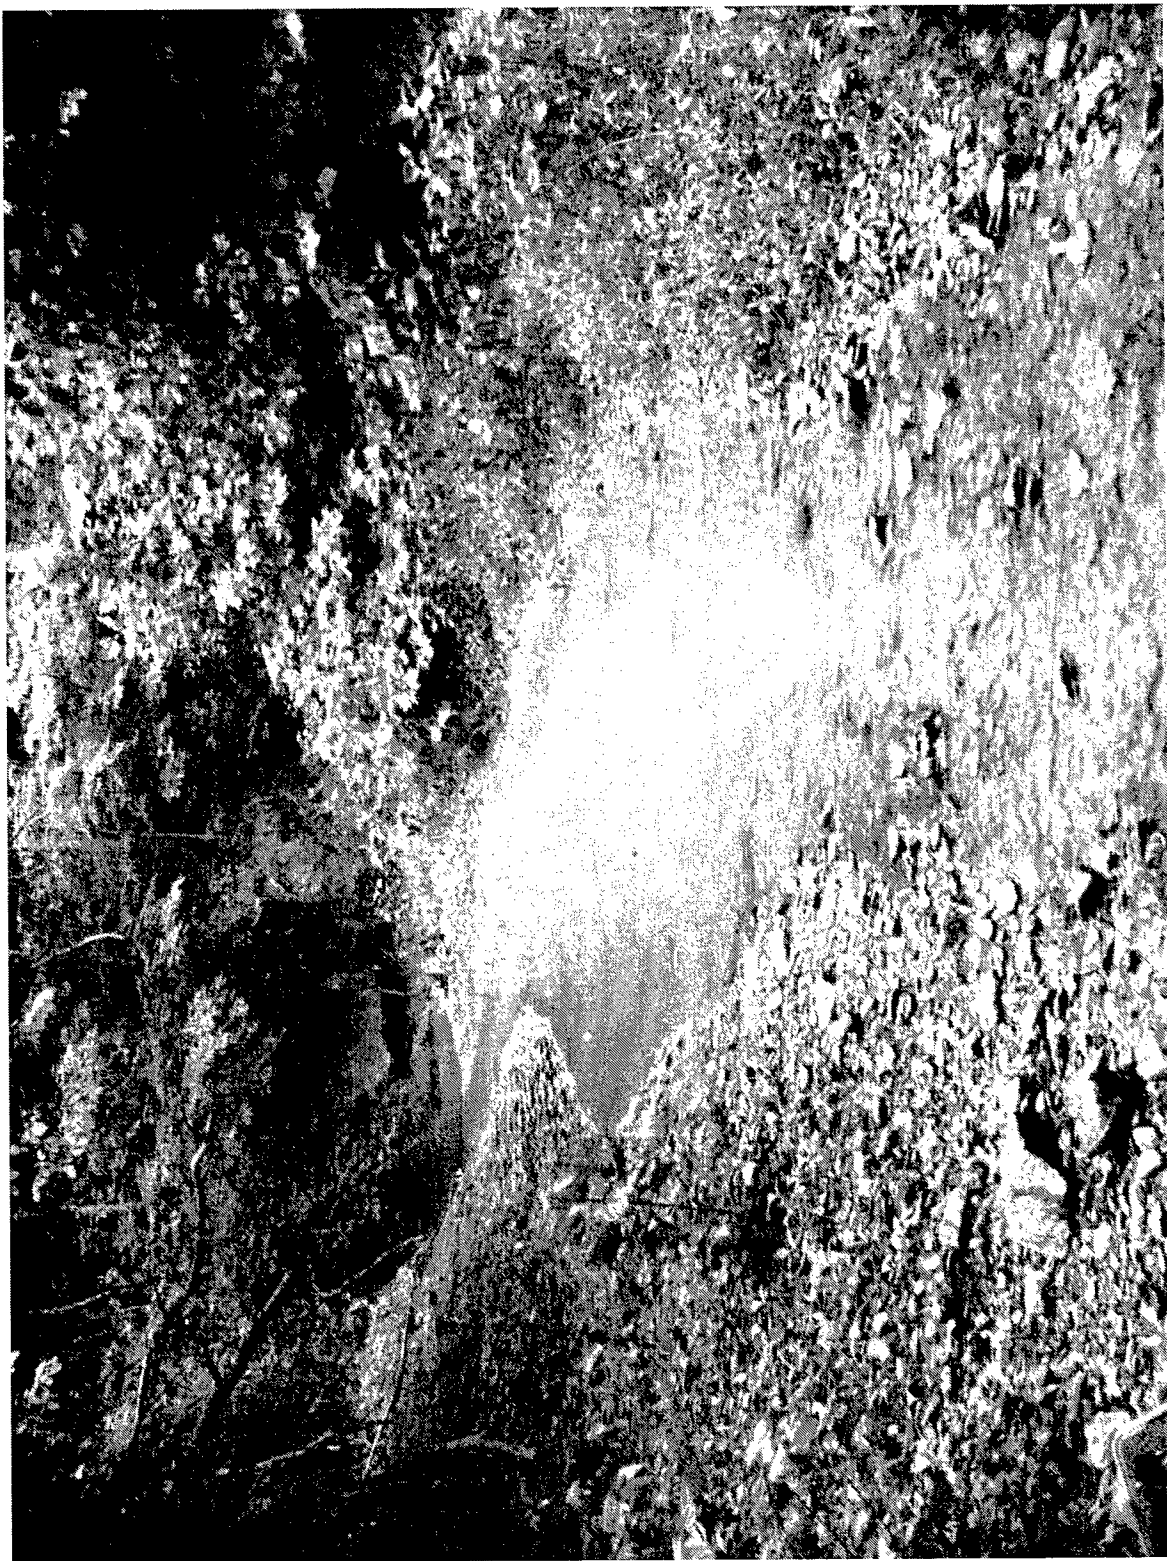
Castleman Creek was sampled at four locations. The three upstream sites (Sites 1-3, all in the valley leading toward Shepherd Cemetery) were similar in that the streambed at these locations was essentially an erosional riffle with a heterogeneous mix of cobble, gravel, sand, and hard clay at these three sites (Table 2; Photographs 5, 6 and 7). At each

Photograph 6. Upstream view of Site 2 in Castleman Creek.

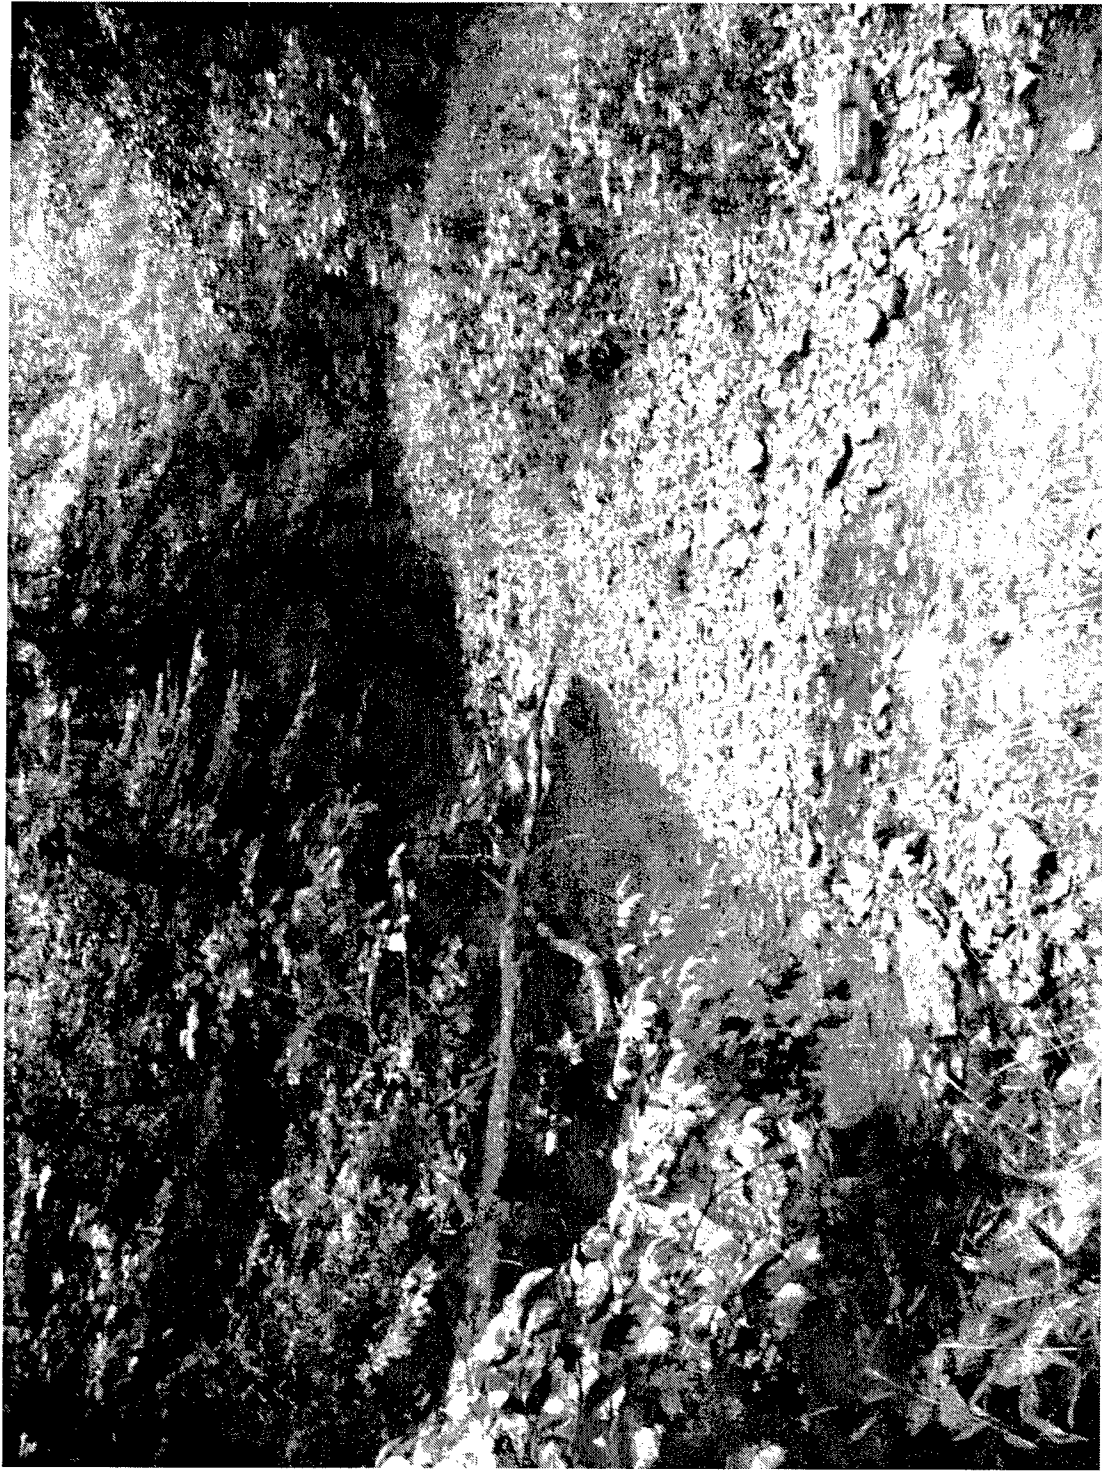
Photograph 7. Downstream view of Site 3 in Castleman Creek showing herbaceous and young woody vegetation growing in dry cobble streambed.

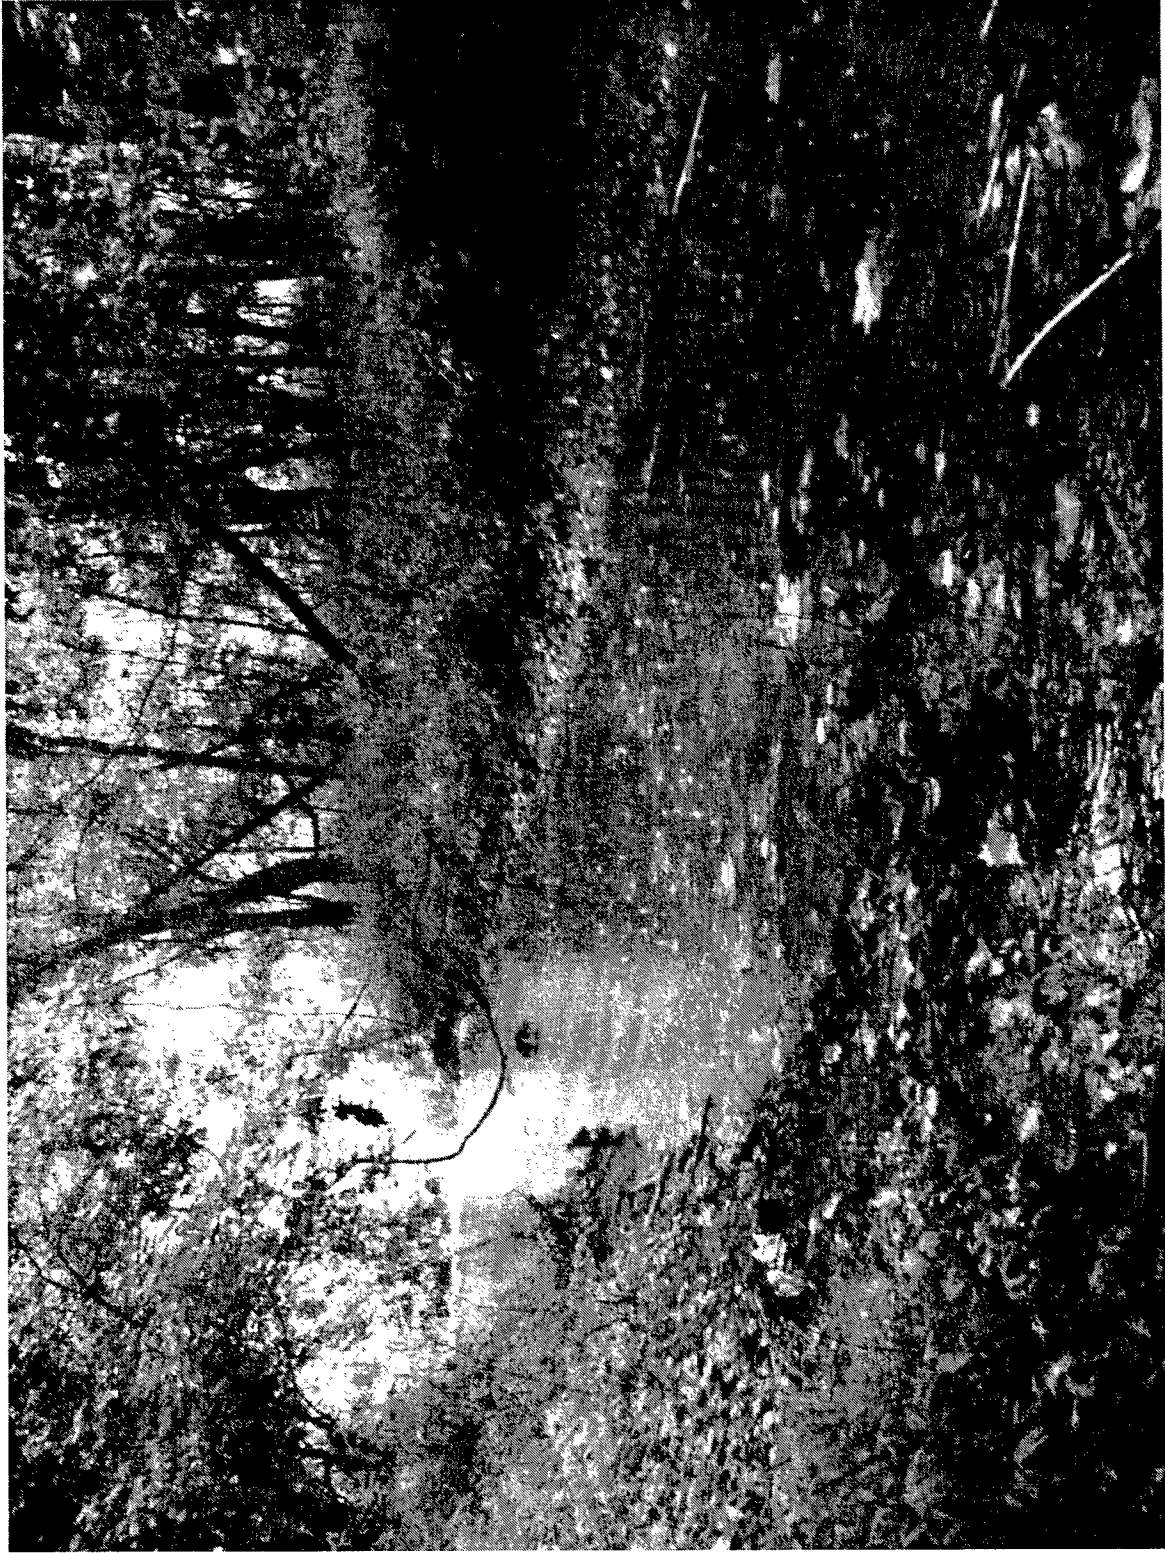
site, pools with accumulated leaf litter were associated with scoured holes below root wads of large trees along the bank. In contrast, the downstream site (Site 4) was on the alluvial floodplain of the Salt River just upstream of Duck Lake and Pitts Point Road; this site was depositional with deep (and anoxic) deposits of soft clay, silt, and leaf litter (Table 2; Photograph 8).

The streambed at Site 4 was formed as a 25 ft wide channel through alluvial floodplain soils. The forest canopy was extremely dense at Site 4. The anoxic substratum at Site 4 smelled strongly of hydrogen sulfide when disturbed. There was no evidence of organic pollution.

Photograph 8. Downstream view of Site 4 in Castleman Creek with the sunny opening downstream indicating the location of Pitts Point Road.

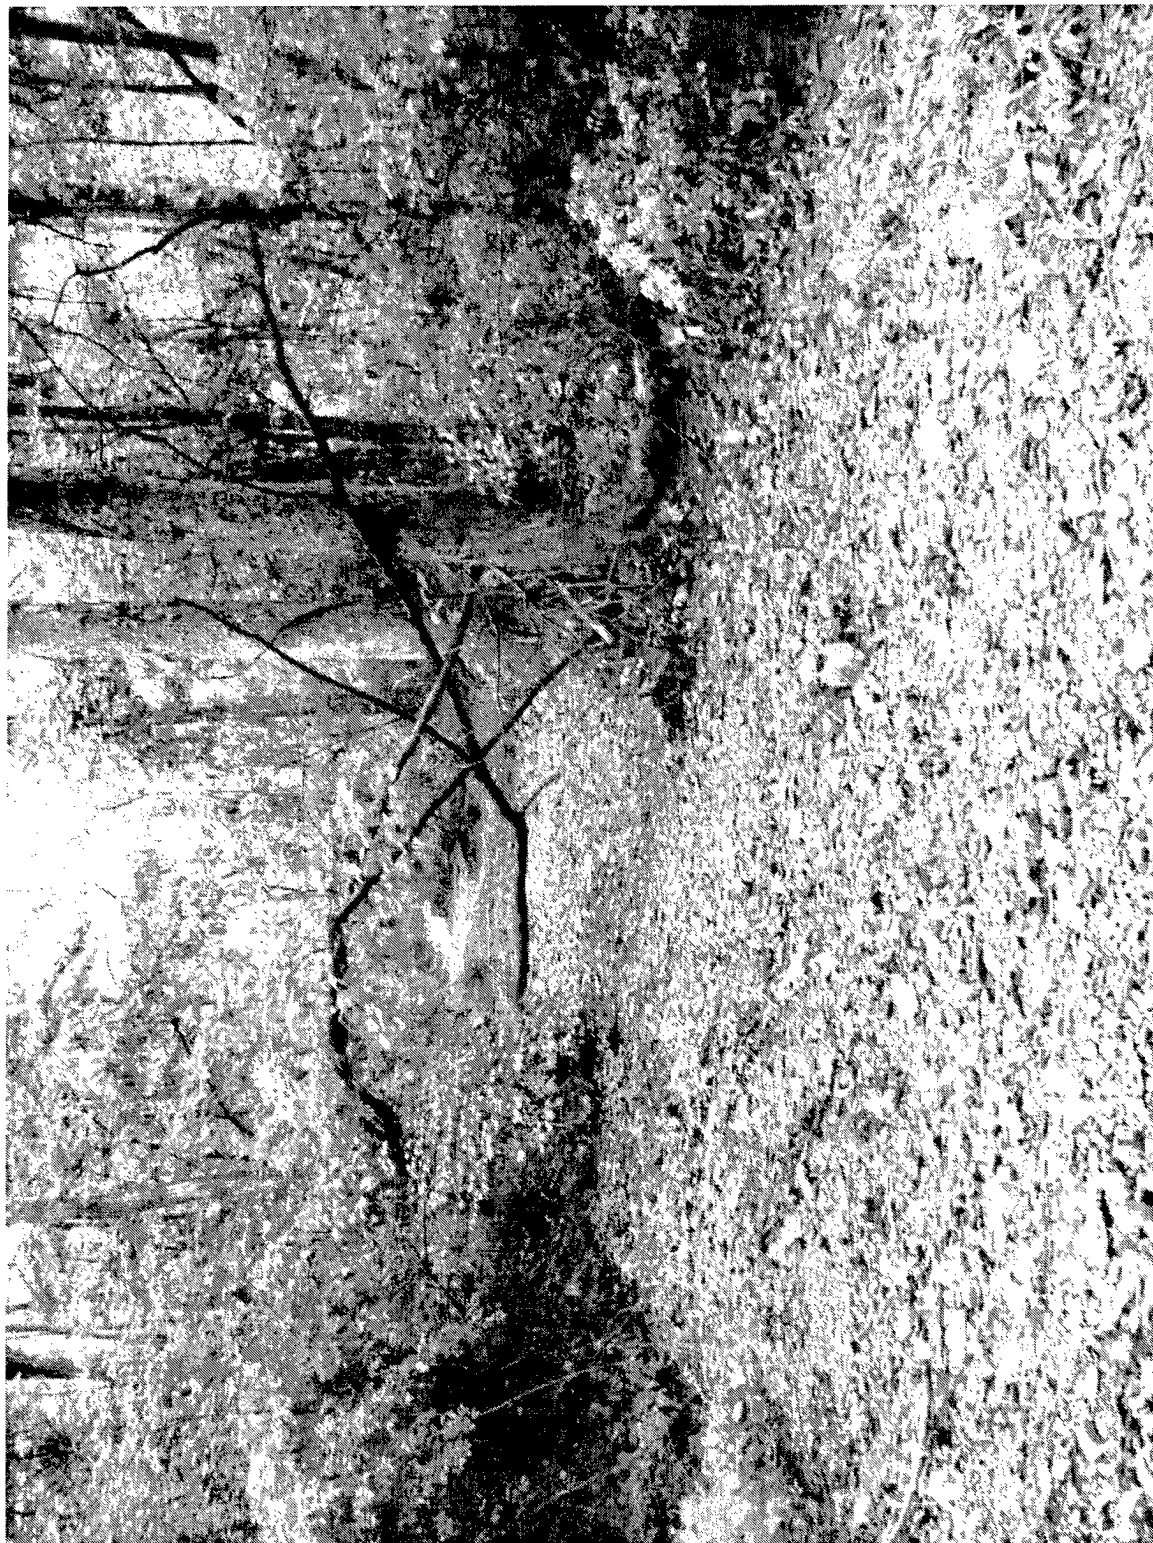
Two sites were investigated in this drainage. Both were dry. The upstream site was a 30 ft wide channel of large and medium cobble with some gravel and sand (Photograph 9). Bank height was approximately 2 to 3 feet. Scour holes below large trees at the edge of the channel provide the only pool habitat in an otherwise continuous riffle. No water was found even in these scour holes. The downstream site (Site 2; Photograph 10) was near Pitts Point Road in the same general area as the downstream site in the closely adjacent Castleman Creek. The channel was very similar to that at Site 1. One scour hole held a few gallons of water; however, the near total lack of permanent water precluded sampling of Woodland Creek. The cobble streambed was evidence that this creek occasionally conveys swift scouring flow despite being dry during low flow seasons.

Photograph 9. Upstream view of Site 1 in Woodland Creek showing the dry gravel and cobble streambed and a small scoured depression at the base of a large tree on the left descending bank.

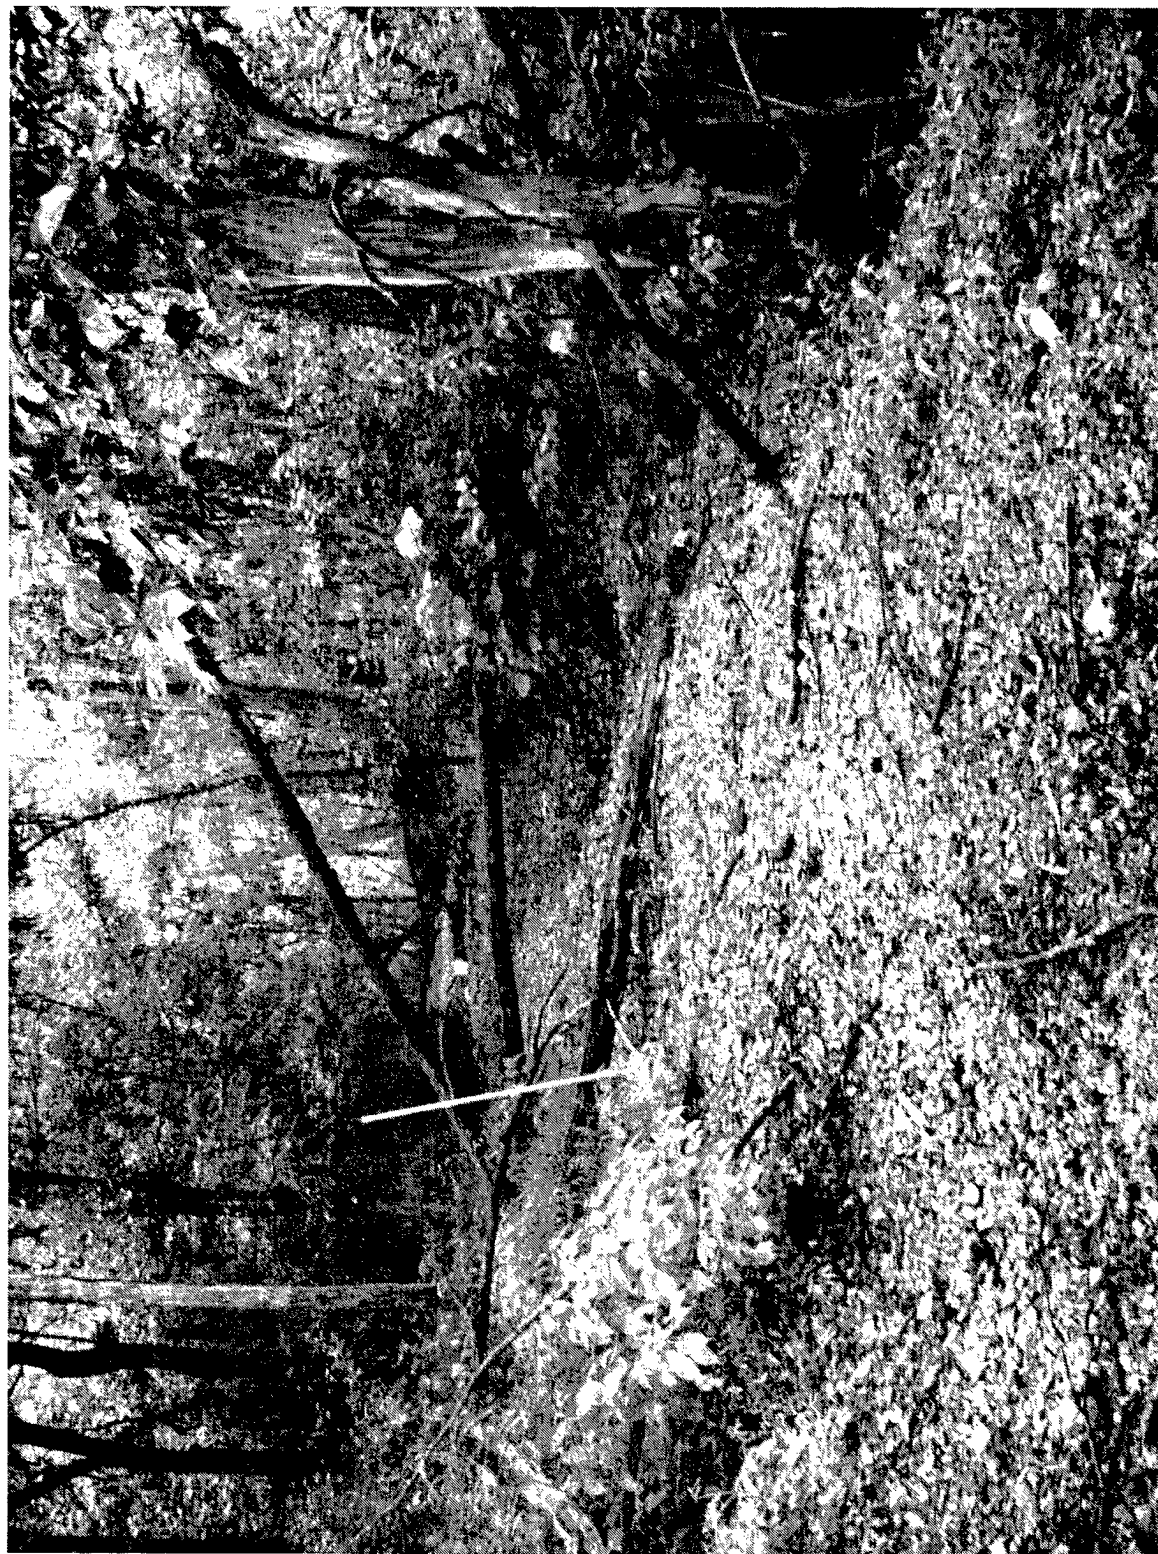
Photograph 10. Downstream view of Site 2 in Woodland Creek showing dry gravel and cobble streambed.

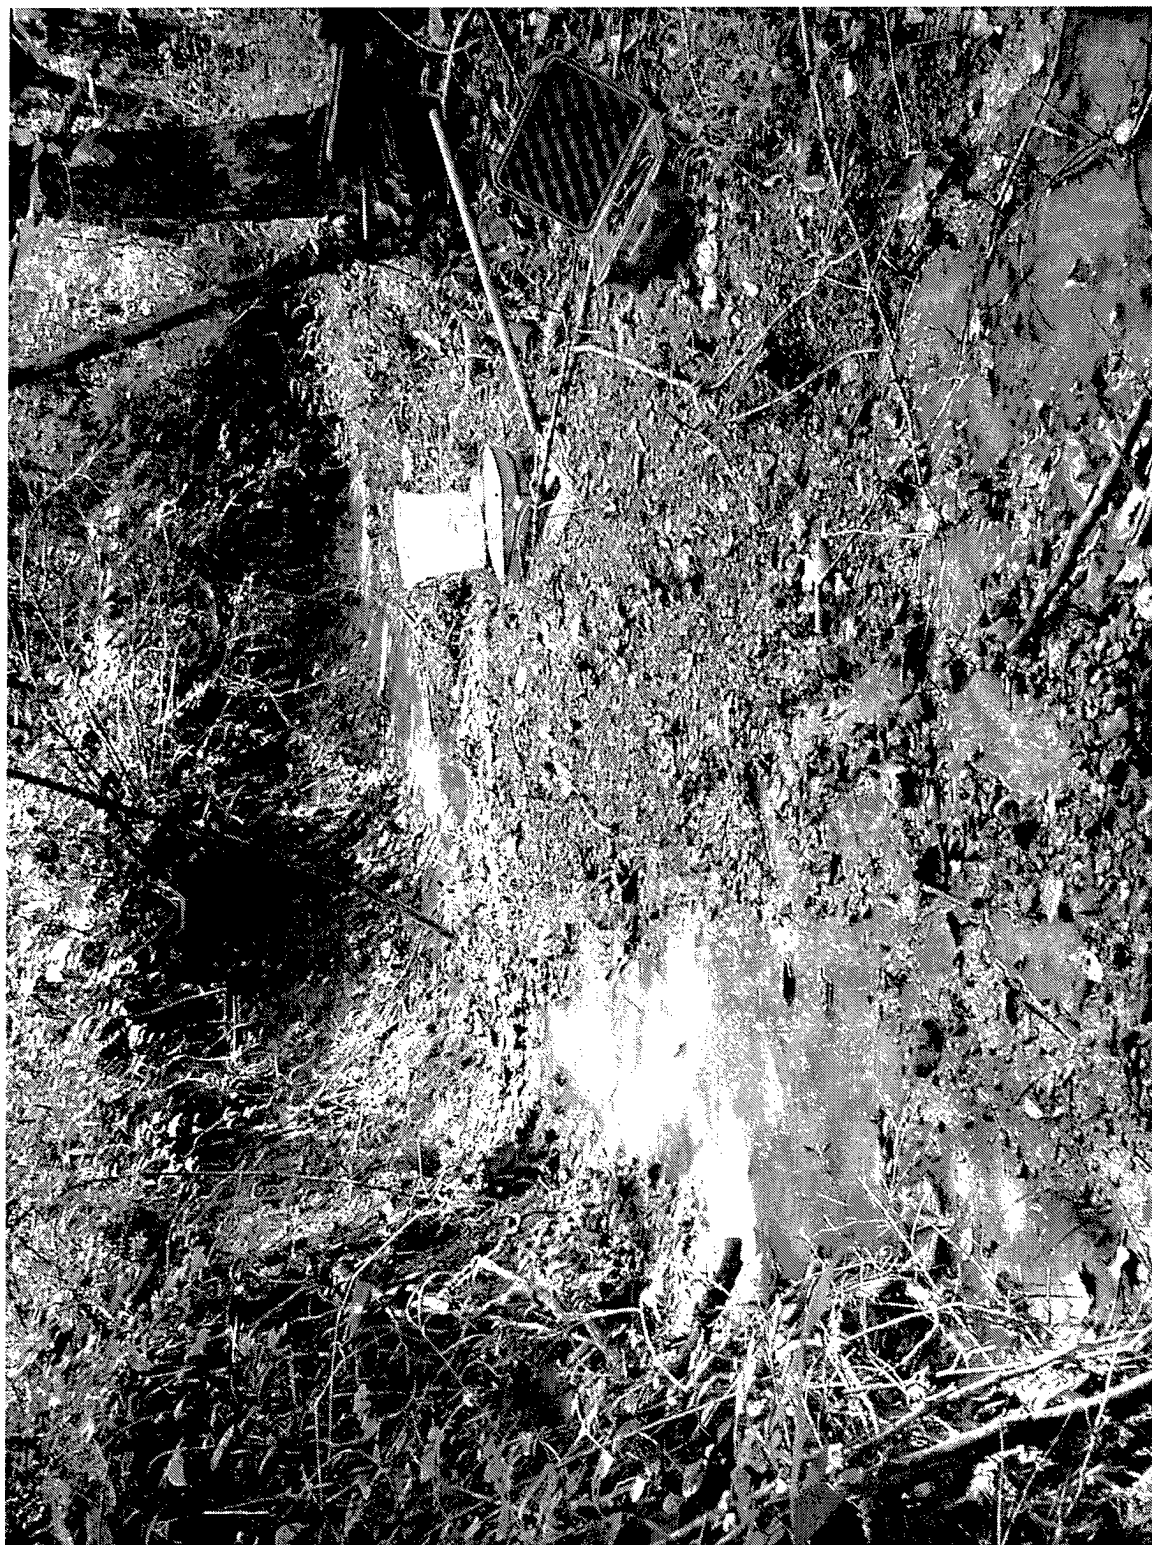
Site 1 was a narrow pool along the left descending bank, approximately 120 ft long, 3 ft wide, and 6.5 feet deep (Photograph 11). The stream channel was only 10 to 15 ft wide; bank height was 3 to 4 feet. Channel substratum was a mix of some cobble with much gravel, silt, and soft clay (Table 2). Clay and leaf litter deposits smelled of hydrogen sulfide when disturbed. There was no evidence of organic pollution. Surrounding woodlands were second growth on abandoned farmlands (old barbed wire fencing ran along the left descending bank).

Photograph 11. Downstream view of Site 1 in Mud Creek tributary showing slightly turbid pooled water mainly along the left descending bank.

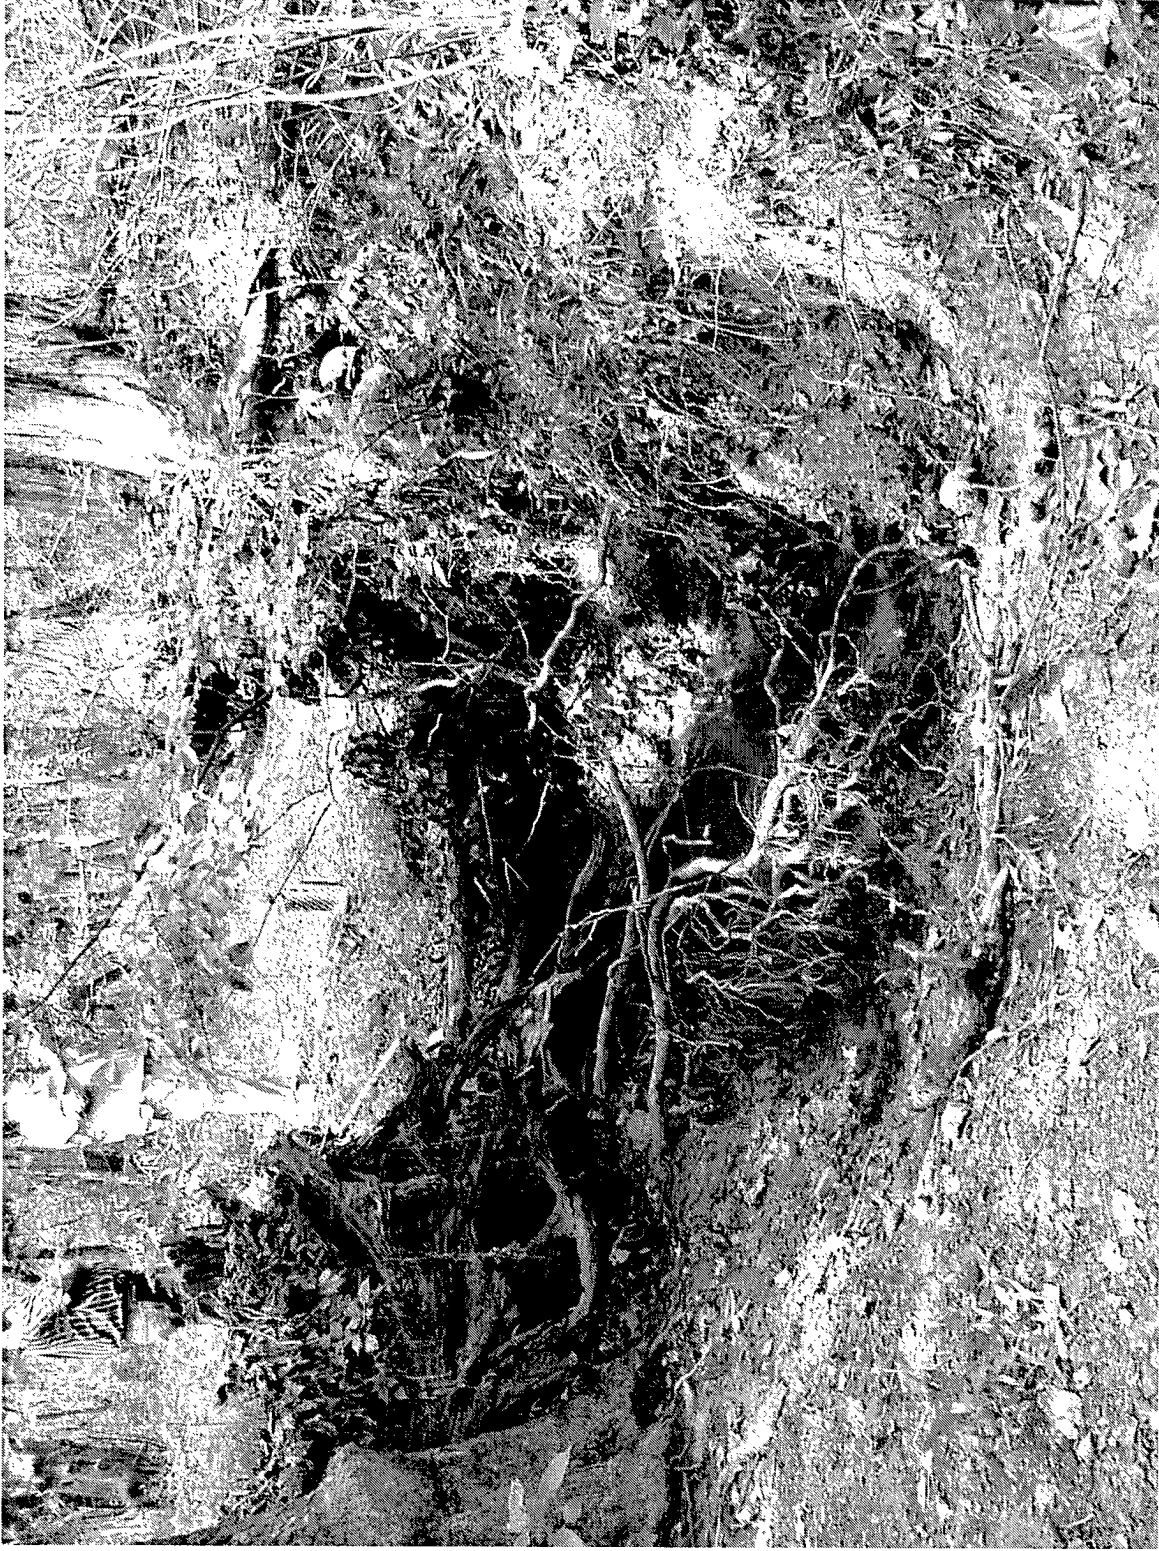
Site 2 was approximately 300 ft downstream (and was the next available pool of water). This site was a deep (3 ft) but small (4 ft diameter) scour hole under a root wad of large tree along the left descending bank (Photograph 12). Substrate was clay with dense leaf litter (Table 3). The substrate smelled strongly of hydrogen sulfide upon sampling.

Photograph 12. Upstream view of Site 2 in Mud Creek tributary a pool of water in a scoured area where the stream bends between two large trees on the banks.

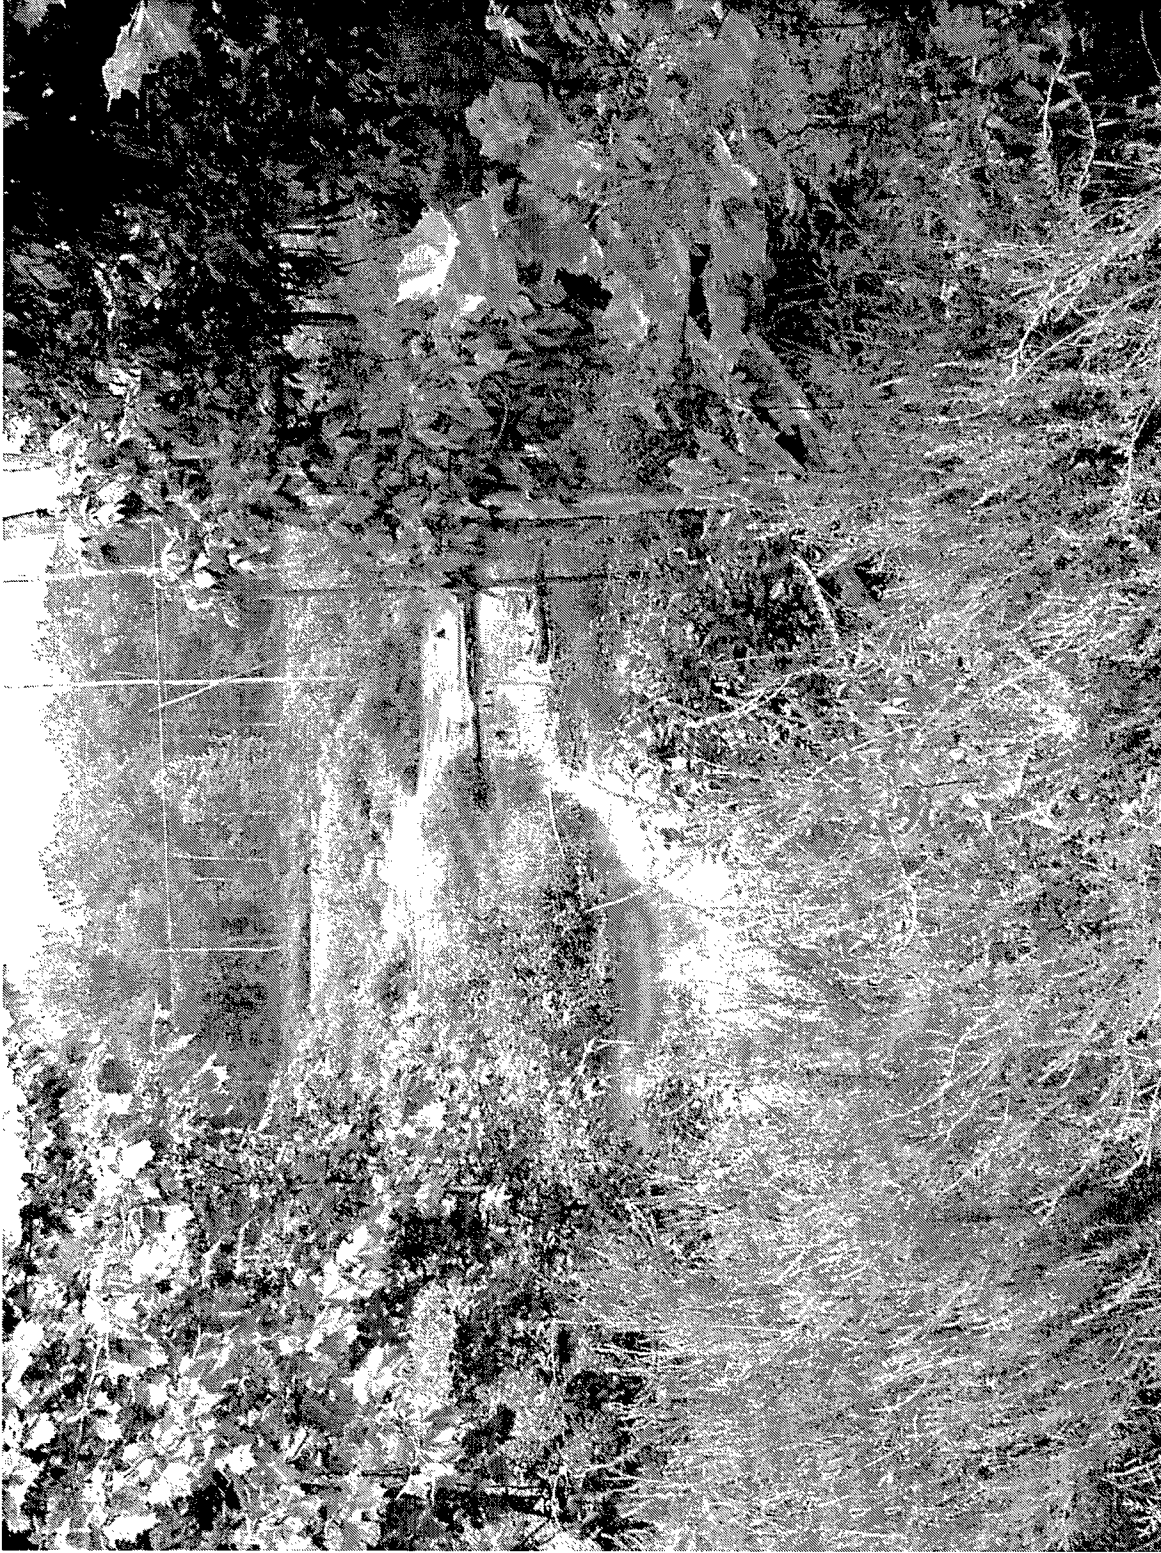
Photograph 14. Pearl Pond on Mud Creek downstream of Pitts Point Road.

Site 3 was a shallow muddy pool in a depression along the lower stream channel (Photograph 13) that meanders through the broad alluvial and forested floodplain of the creek as it approaches Pearl Pond (Photograph 14). Oligochaetes, decapods (the same *Orconectes* sp. observed at all sites), gastropods (pulmonate snails of the genus *Helisoma*), and chironomids were all common but not abundant (Table 7). A single sphaeriid bivalve was also found. Laboratory processing of a subsample of the soft sediment and leaf litter at this location revealed several very small (recently released young) sphaeriid bivalves, indicating that this taxon is common at this site (Table 5). Many small chironomids (Chironominae) were also found. Isopoda, Hemiptera, Coleoptera, Odonata, and Megaloptera were orders that were rare but present in the sample analyzed in the laboratory.
